INVENTORY FORM FOR STATE HISTORIC SITES SURVEY

Peace and Plenty

Southeast corner U.S. 301 and Maryland 213

Centreville

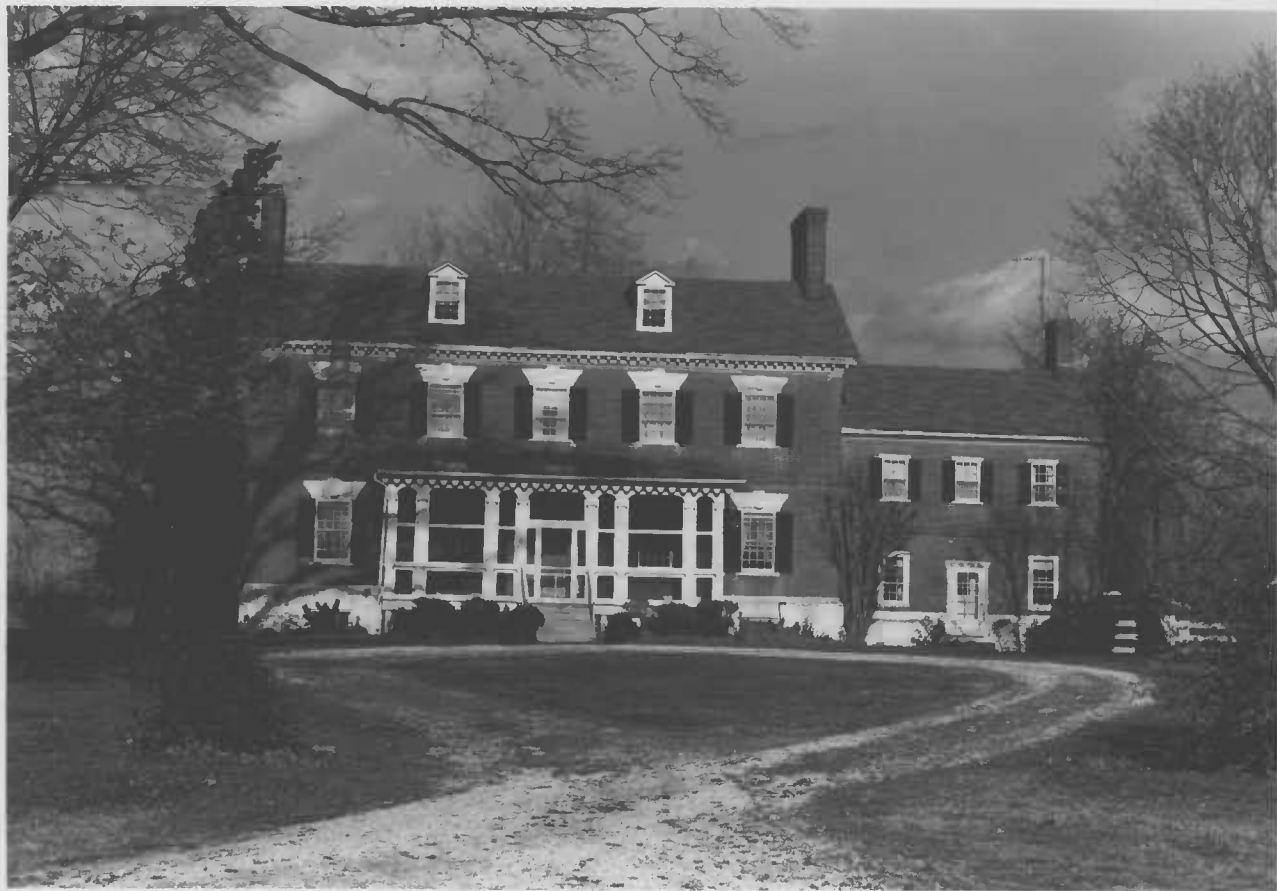
QA-99

Peace and Plenty
Centreville vicinity
Orlando Ridout V 1981
South (front) facade

with tooled "grapevine" joints and queen closers above a molded water table and three-course bond foundation. The water table and foundation have been whitewashed, a common decorative touch of the 19th century. A four-course Flemish bond belt course stretches across the facade between the first and second story, stopping flush with the corners. Splayed wood lintels above each window are rusticated to imitate stone and are painted white. The windows are set in heavy wood frames; molded backband trim survives on the first floor windows. Louvered wood shutters were installed in the latter part of the 19th century. The original front door was replaced in the second quarter of the 19th century with a six-panel door with ogee/astragal panel molds. The door and four-light transom are framed with a Greek Revival surround that includes a reeded Greek architrave with bullseye corner blocks, and simple pilasters with molded caps supporting a heavily molded hood. The most significant woodwork on the facade, however, is the cornice. This consists of a boxed eave with large scrolled dentil blocks below the soffit and a complex bed mold with smaller dentil course. The existing

crown mold is quite plain and is presumably a replacement. The cornice returns at each end against the gable wall. The roof is covered with asphalt shingles. A one story 19th century porch with a hip roof protects the center three bays, replacing an earlier (presumably original) entrance porch in the center bay. One brick pier survives from the earlier porch, concealed by the existing porch.

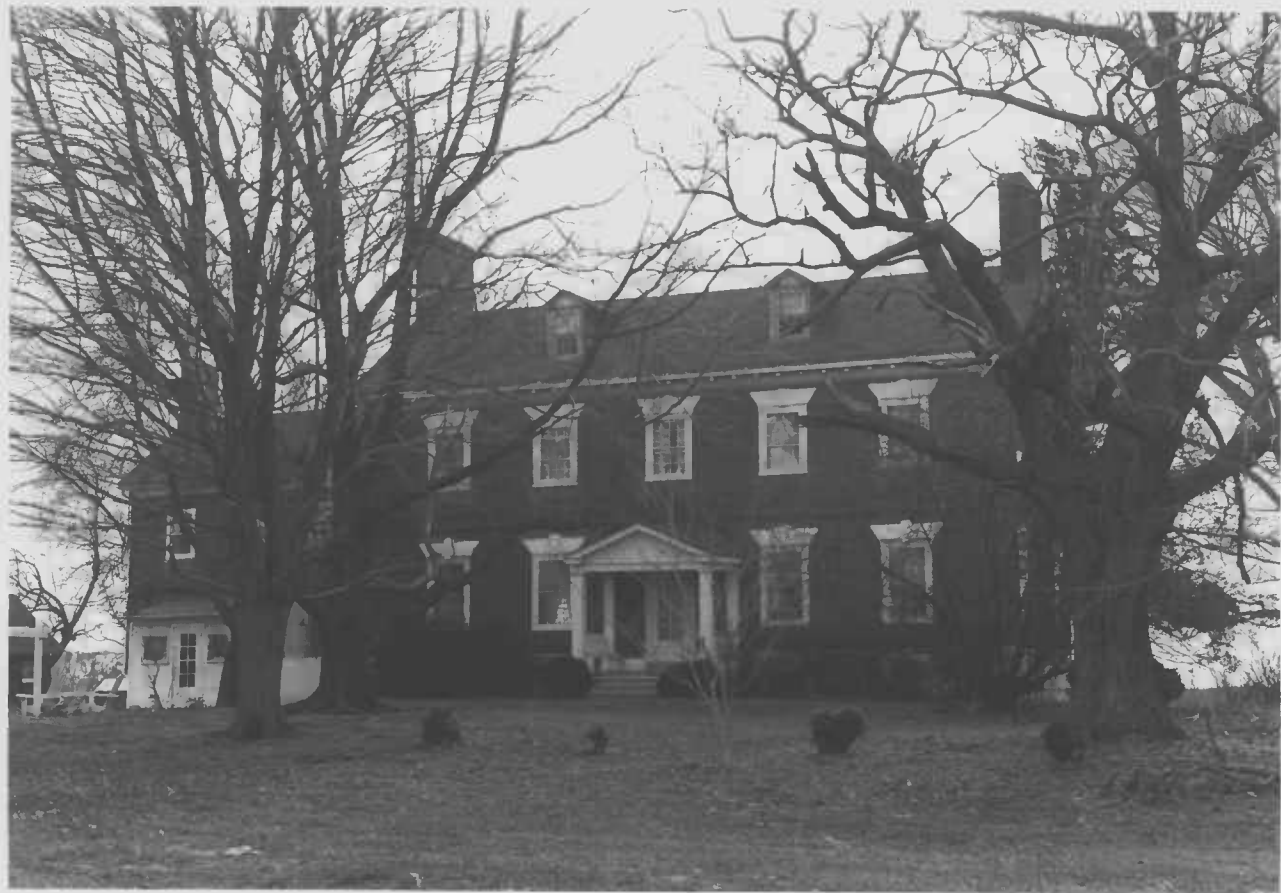
QA-99

Peace and Plenty
Centreville vicinity
Orlando Ridout V 1981
North facade

all date to the second quarter of the 19th century. The west cellar window has been bricked up and the bulkhead cellar entrance has been shifted from the right of the door to the left of the door. The brickwork matches the front facade as well. The rusticated lintels have been replaced in the east and west bays on the first story. A one story entrance porch in the center bay probably dates to the early 20th century.

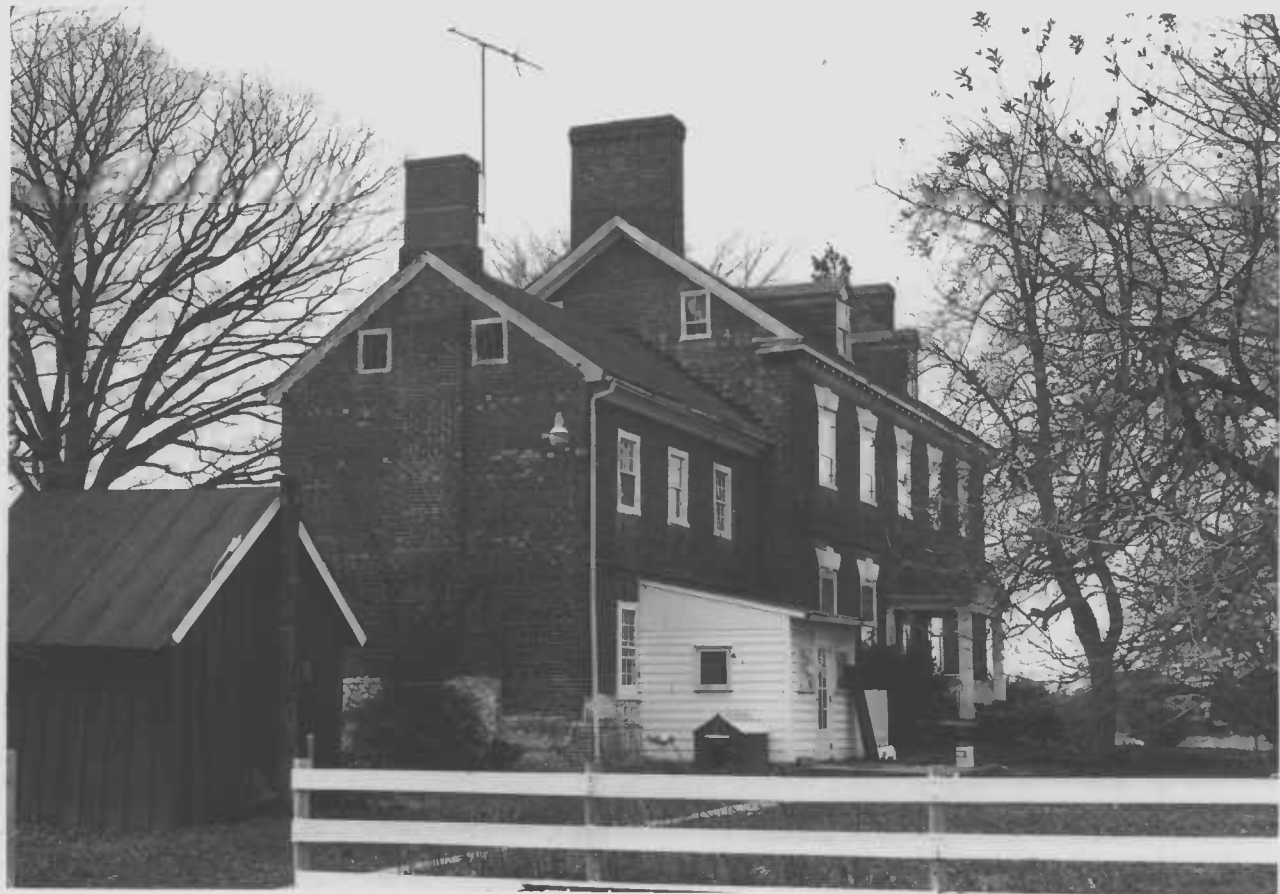
QA-99

Peace and Plenty
Centreville vicinity
Orlando Ridout V 1981
View from Northeast

On the east gable wall of the wing, the chimney projects out approximately nine inches from the wall surface. It shoulders in above the first story fireplace and corbels back in flush with the upper gable. The only openings in this wall are a pair of small, boarded-up windows flanking the chimney in the upper gable. The brickwork is laid in three-course bond above a molded water table and three-course bond foundation. The eaves are trimmed with wide rake-boards and plain crownmold. The chimney shaft has been rebuilt above the ridge.

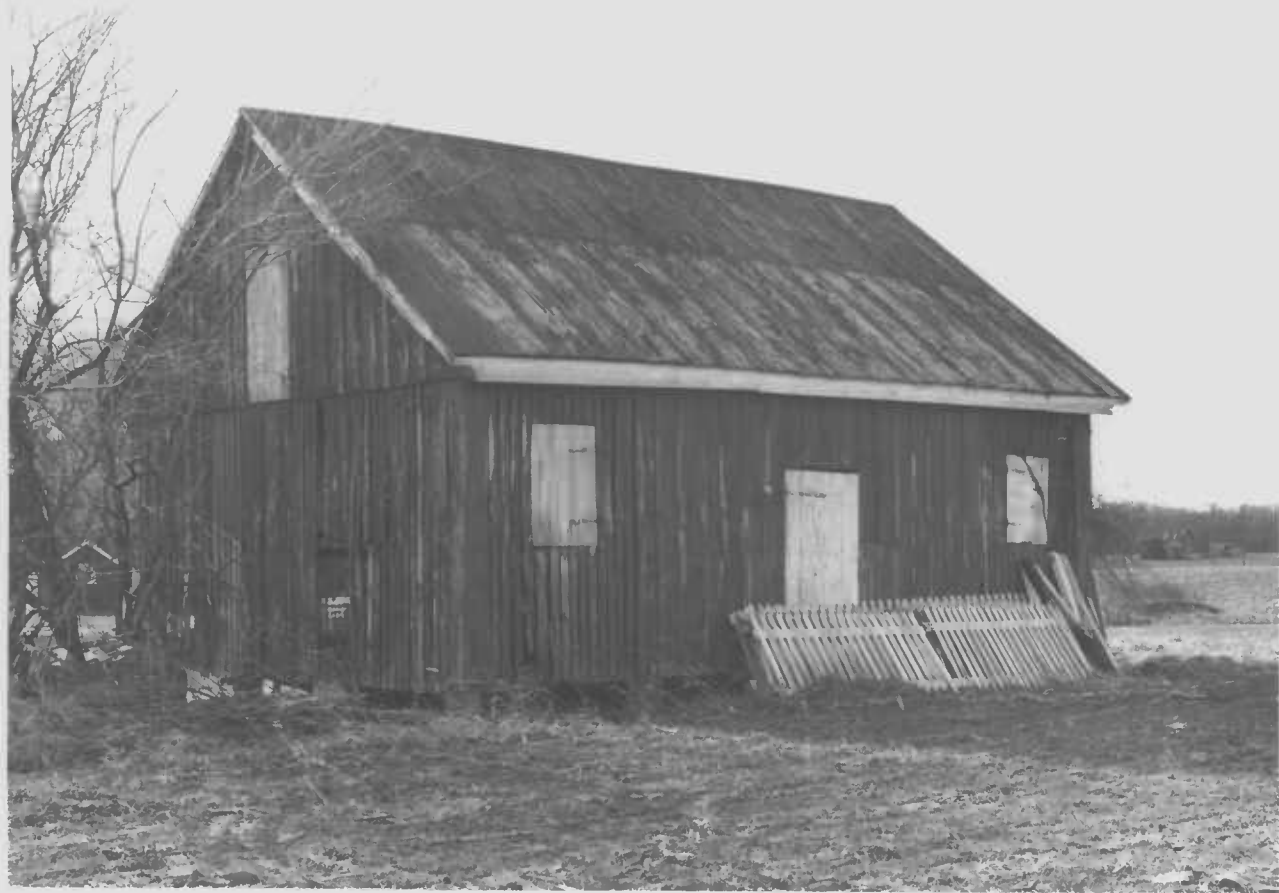
QA-99 Peace and Plenty
 Centreville vicinity
 Orlando Ridout V 1981
 Granary, from northeast

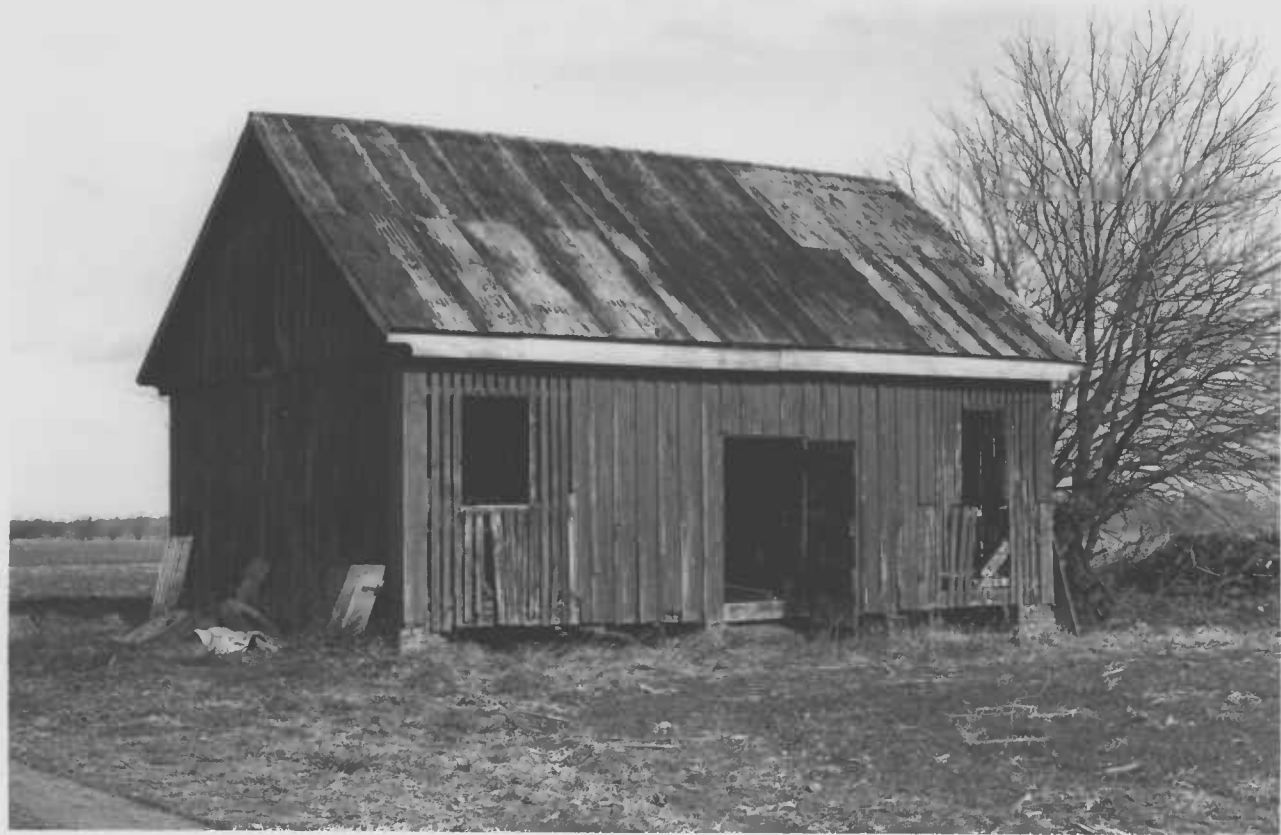
QA-99

Peace and Plenty
Centreville vicinity
Orlando Ridout V 1981
Granary, from southwest
